Montana Asbestos-Safe Weatherization Demonstration Project

Final Report - June 30, 2010

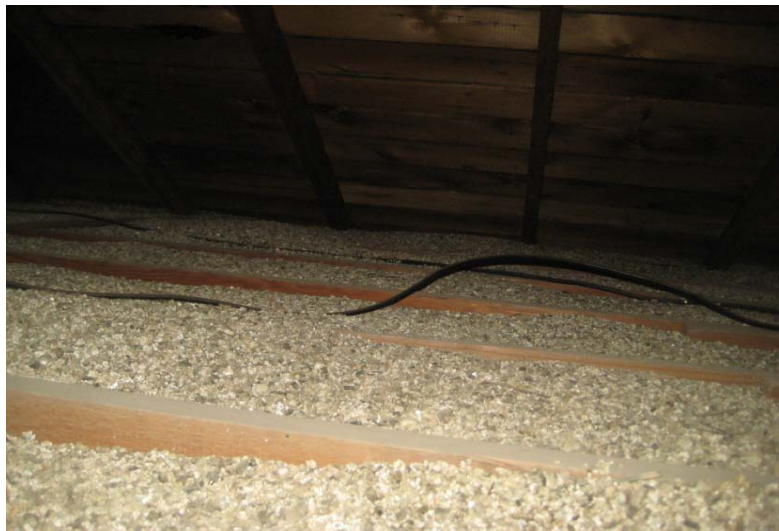
Figure 1
Example of asbestos-containing vermiculite attic insulation.

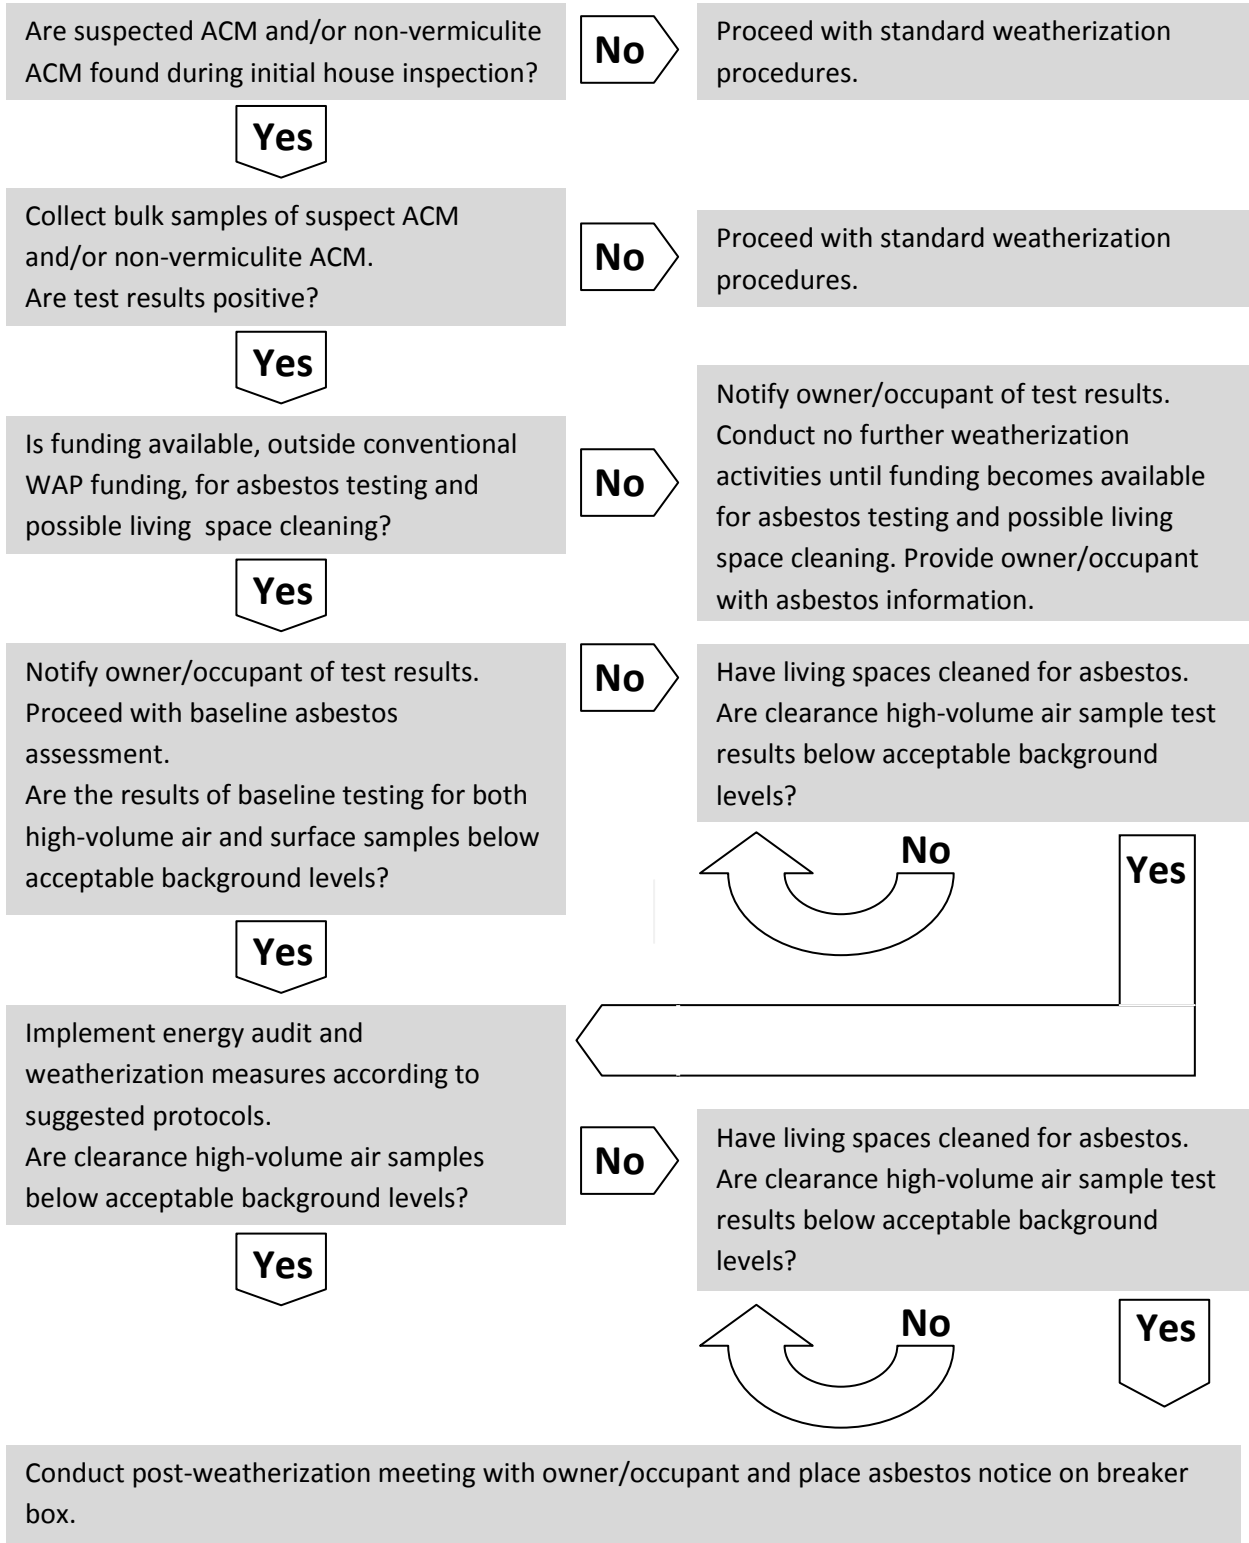
Asbestos Safe Weatherization Project Protocol Decision Tree

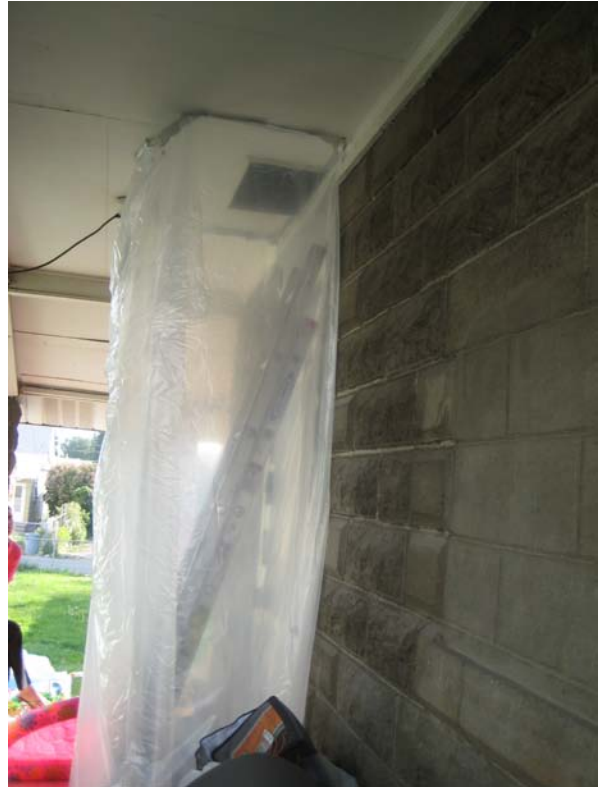
Figure 2

Example of containment constructed around attic hatch.

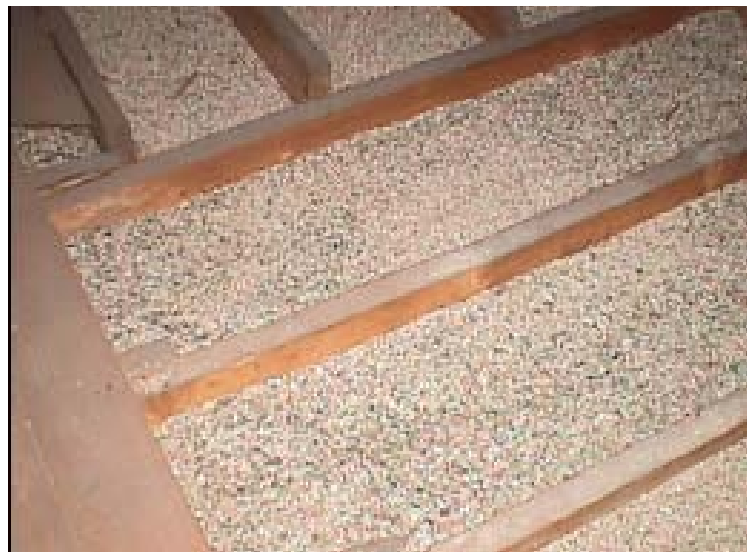
Figure 3

Vermiculite attic insulation

After gathering a sample of vermiculite insulation and collecting pictures to assist with a visual observation of the attic, the researcher came out of the attic, wiped down equipment and personal protective equipment with wet wipes and ,finally, removed the plastic containment for disposal.

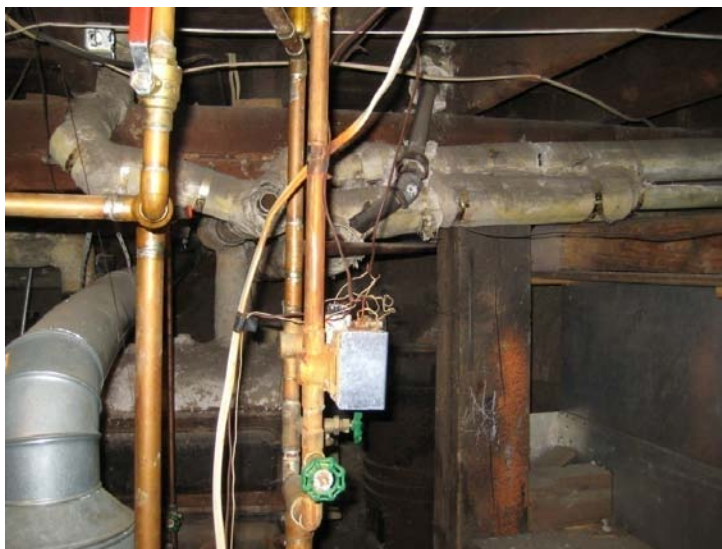
Figure 4

Example of thermal system insulation (TSI) in mechanical room.

The area where a bulk sample was collected was contained with 6-mil plastic. A researcher then donned nitrile gloves and reached into the containment to remove a full-depth sample with tweezers that is ¼- to 1-inch long. The sample was then placed in a plastic bag and the bag was sealed, labeled, and wet-wiped. The tweezers were then wiped with a wet wipe, along with the nitrile gloves, prior to disposal. Bulk samples were sent to DataChem Laboratories for analysis via PLM for asbestos and other fibrous constituents using EPA-600/R-93/116.

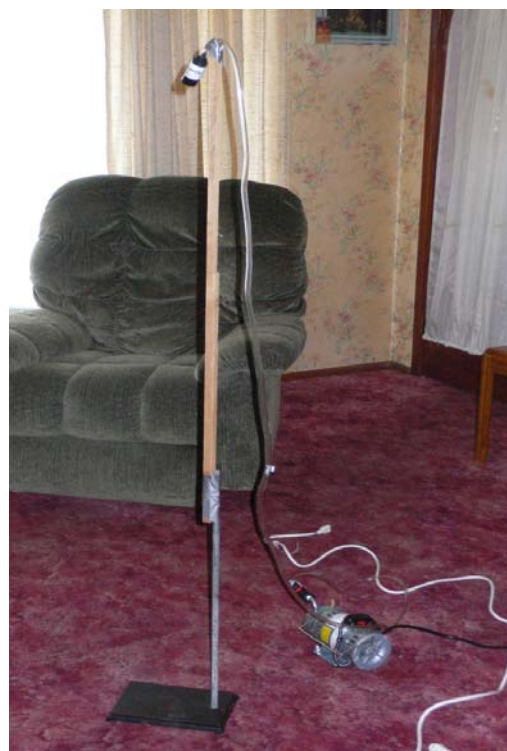
Figure 5

Example of high-volume air sampling placement in a home.

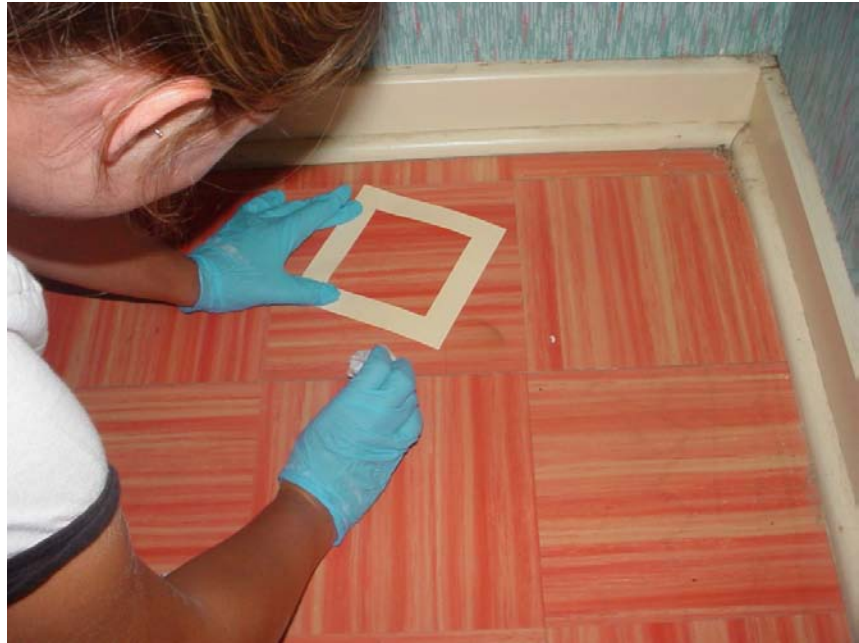
Figure 6

Example of surface wipe sample collection on non-porous flooring.

Surface samples were collected from numerous locations in various rooms via wet wipe and micro-vacuum techniques. Wipe samples were collected from floors, interior window sills, ductwork, or unmovable furniture and appliances. The wipes were collected using the American Society for Testing and Materials (ASTM) D 6480-05 procedures, Wipe Sampling for Settled Asbestos (ASTM, 2006) and analyzed by TEM by Data Chem Laboratories. A disposable 10x10-centimeter disposable manila template was placed in the desired location and a SKC Ghost Wipe pre-moistened with deionized water was used to collect the sample (Figure 6.).

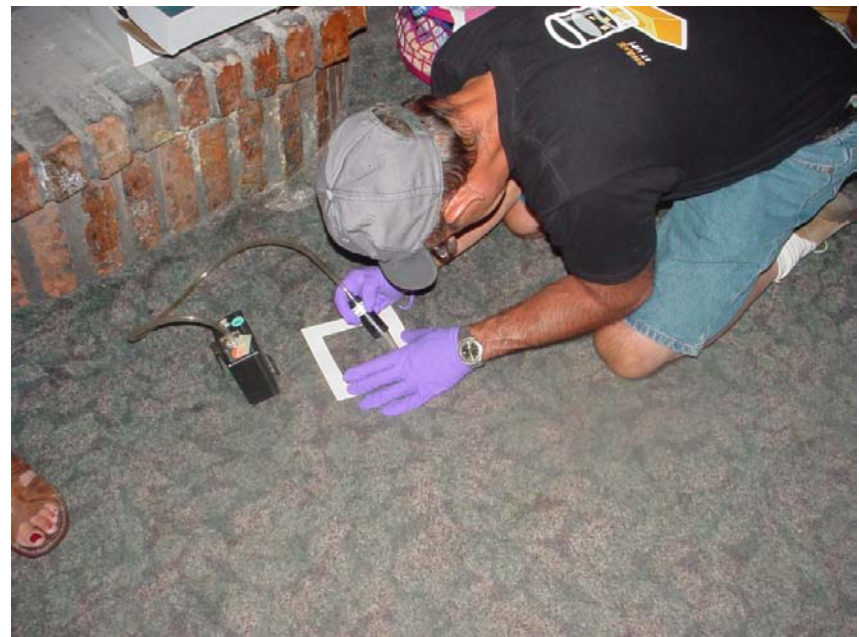
Figure 7

Example of micro-vacuum sample collection from porous carpet.

Micro-vacuum samples also were taken throughout homes on surfaces not suitable for surface wipes (carpets, porous furniture) using ASTM method D5755-02 (ASTM, 2007). A disposable, 10x10-centimeter manila template was placed on a surface and a sample probe was moved over this surface for two minutes (Figure 7.) The sample probe consisted of a 3/4-inch long section of Tygon tubing attached to a 25-mm asbestos sampling cassette. The sample cassette was fitted with a 25-mm, 0.8 μm MCE filter. The cassette was attached to an SKC Aircheck sampling pump. The sampling pump was calibrated pre- and post-sampling at 2 liters per minute (L/min) with a Bios Defender 510 dry cal primary flow calibrator. Micro-vacuum samples were typically

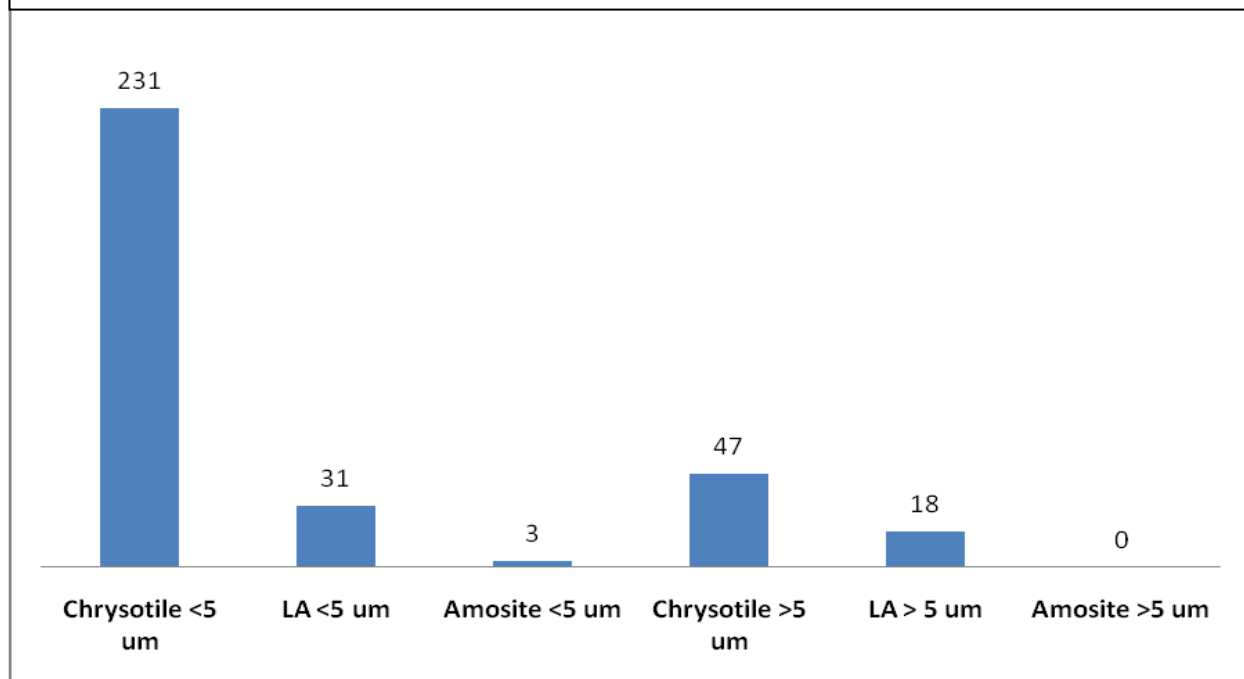
Figure 9. Asbestos Fiber Counts by Type and Length of Asbestos Detected in High-Volume Air Samples

Airborne asbestos was detected in high-volume samples in 28 of the 37 homes weatherized. Of these, chrysotile asbestos was detected in the air in 26 homes, and Libby amphibole (including actinolite-tremolite), was detected in 14 homes. Eleven homes had both Libby amphibole (LA) asbestos and chrysotile detected in the air during weatherization activities. LA was detected alone, without the presence of chrysotile, in air samples in three homes. Amosite asbestos, probably associated with TSI, was detected in three air samples from two different homes. Figure 9 below shows the asbestos fiber counts by type and fiber length of asbestos detected in high-volume air samples during weatherization activities. The most common type of asbestos detected in high-volume air samples was chrysotile, and the majority of fibers detected were less than 5 um in length.

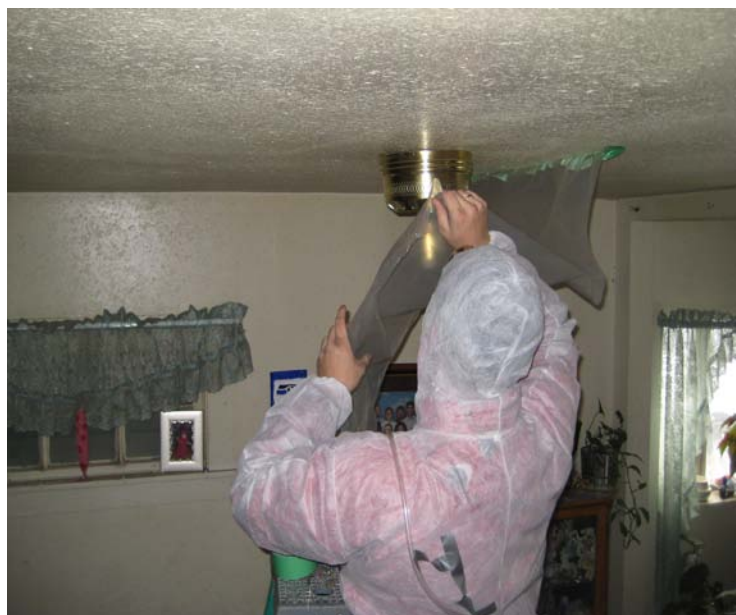
Figure A1

Wrapping plastic around light fixture to prepare for sealing of potential attic bypass.

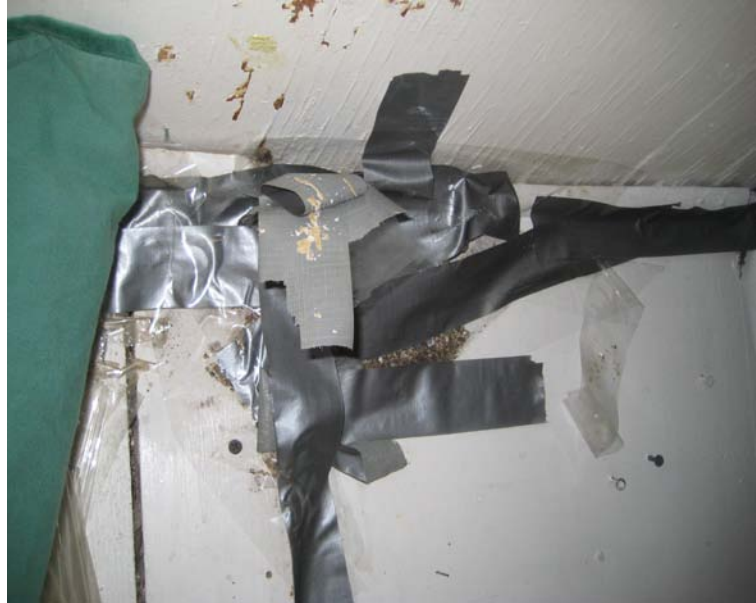
Figure A2

Example of hole at wall and ceiling intersection allowing vermiculite to enter living space.

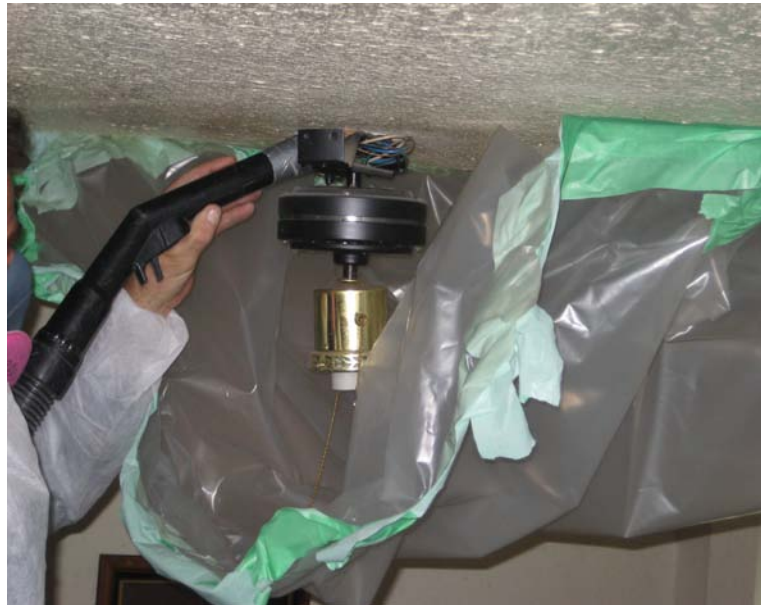
Figure A3

Weatherization crew member HEPA vacuuming light fixture prior to sealing this potential attic bypass.

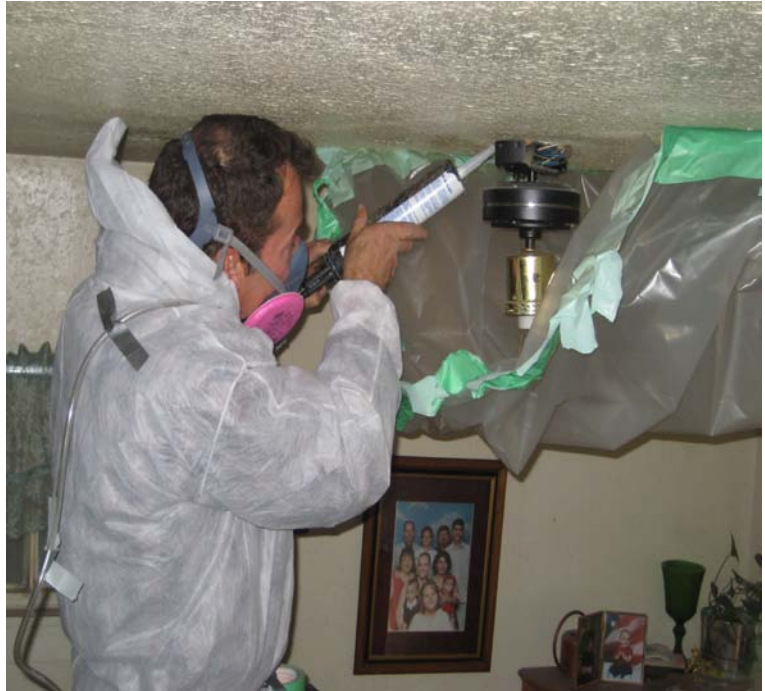
Figure A4

Crew member sealing light fixture, a potential attic bypass.

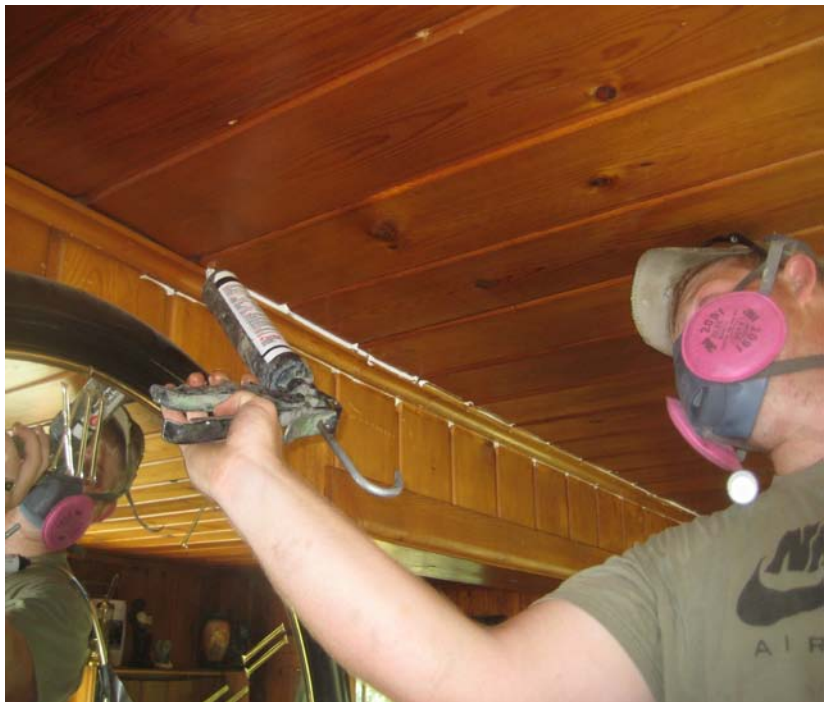
Figure A5

Crew member sealing potential attic bypass into living space.

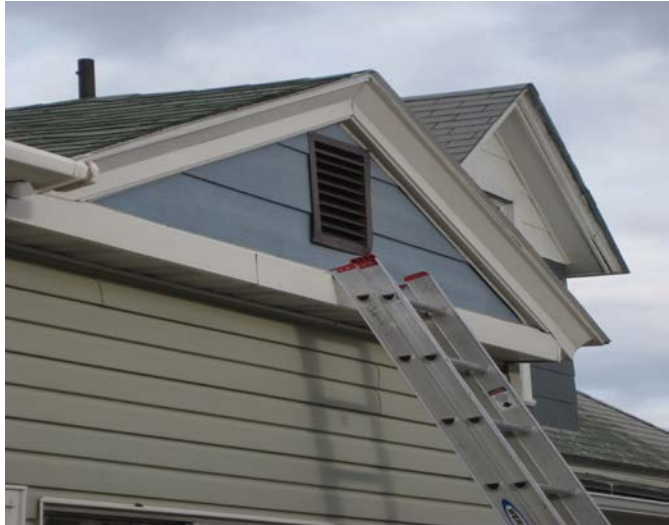
Figure A6
Exterior attic access installed
by weatherization crew
member.

2. *Sealing and Relocating Interior Attic Access Hatches.* If the house contained vermiculite attic insulation, the interior attic hatch was permanently sealed and a new attic hatch was installed in the garage or at an exterior gable (Figure A6) prior to the blower door test being performed. Eliminating the interior attic hatch prevents future direct contamination of the living space from the interior attic hatch.

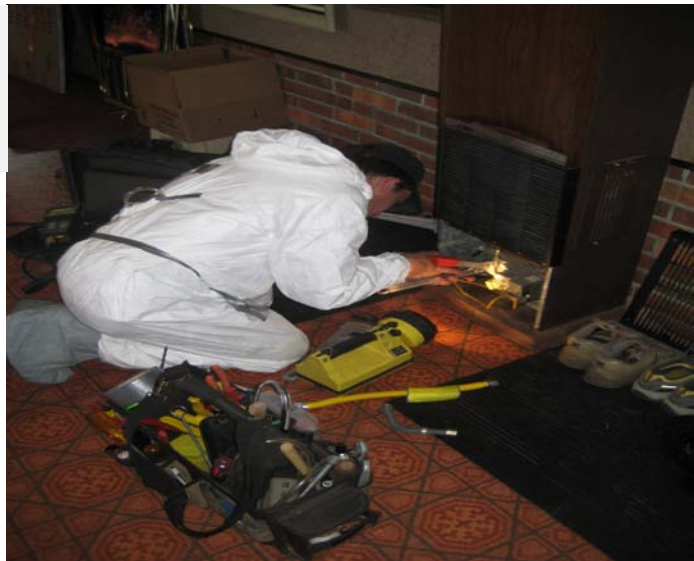
Figure A7
Furnace technician checking
furnace efficiency.

Heating System Inspection and Testing. The auditors identified the type and efficiency of the water- and space-heating systems. Testing was performed to determine efficiency. Safety testing included worst case combustion appliance zone to evaluate the possibility of back drafting. Proper draft was also evaluated.

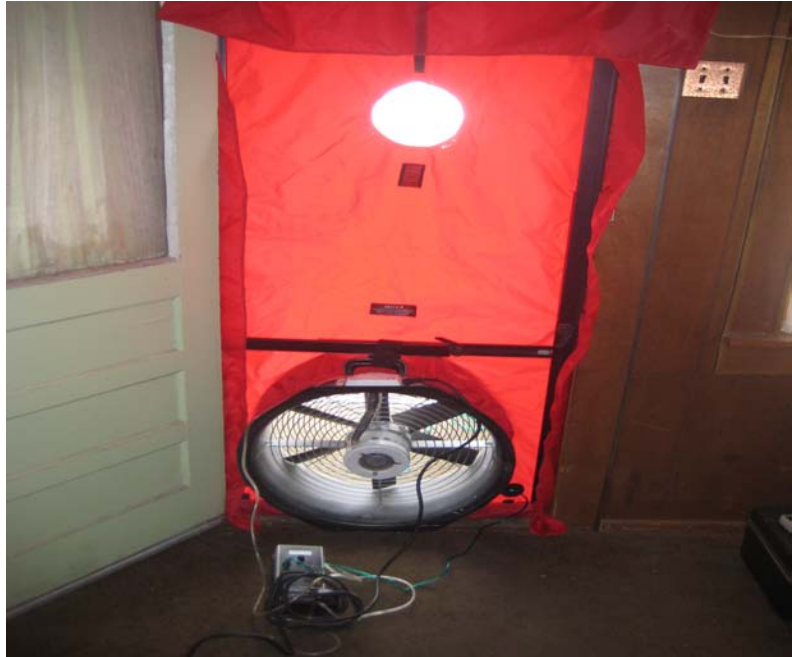
Figure A8
View of interior blower door setup.

The auditors conducted a positive-pressure blower door test to determine building tightness. The blower door (Figures A8, A9, and A10) is a diagnostic tool designed to measure the air-tightness of buildings and to help locate air leakage sites (Figure A11). A Model 4/230 V Minneapolis Blower Door™ system was used during weatherization measures

The blower door consists of a powerful calibrated fan that is temporarily sealed into an exterior doorway. The fan blows air into or out of the building to create a specific pressure difference between inside and outside. This pressure difference forces air through holes and penetrations in the exterior envelope. The measured air flow at the fan is equivalent to the air leaking out of the house.

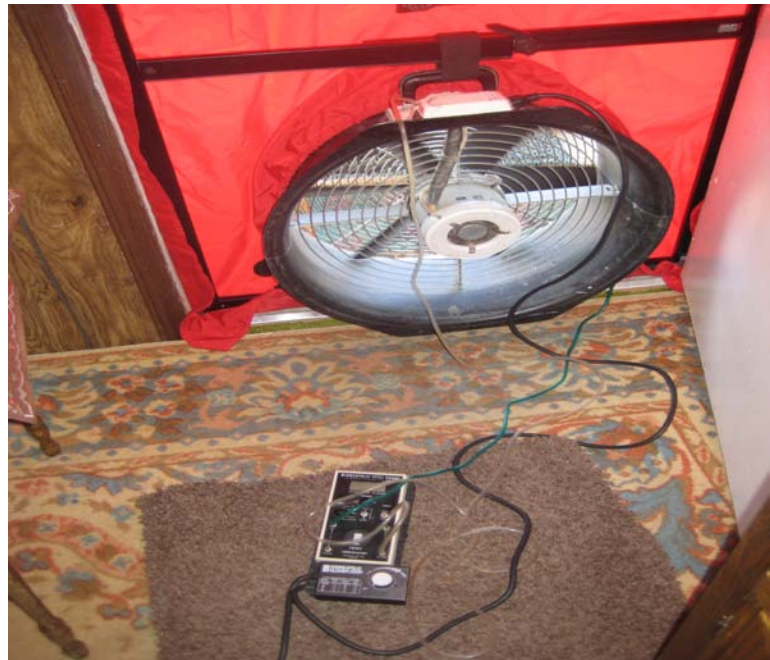
Figure A9
View of blower door fan, fan speed controller and fan flow and pressure gauges.

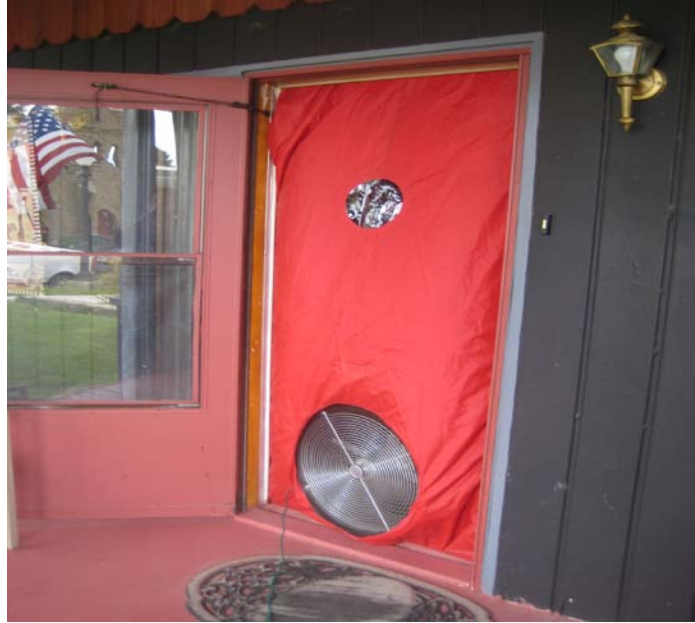
Figure A10

View of blower door from exterior.

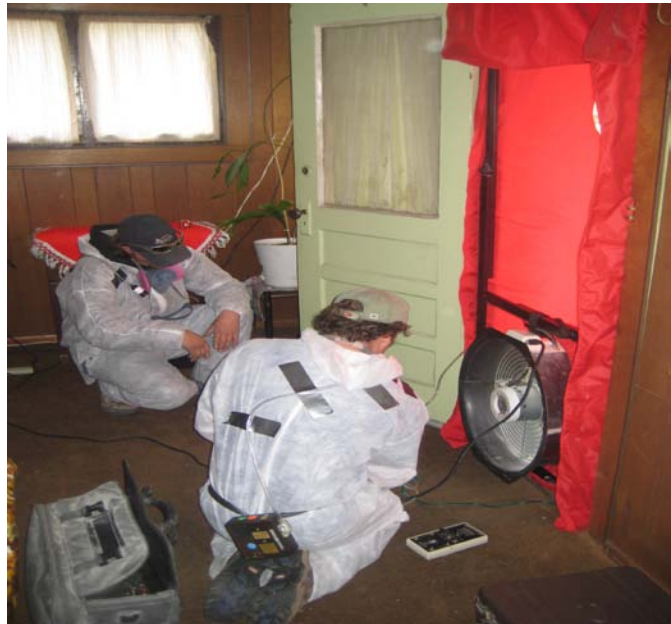
Figure A11

Crew members performing blower door test.

Blower door tests are typically conducted with the building depressurized relative to the outdoors (i.e., the blower door fan exhausting air out of the building). However, under certain conditions (such as in this project), it is necessary to conduct a blower door test by pressurizing the building to avoid the possibility of pulling asbestos fibers from walls, attics or crawlspaces into the building during the test procedure. While the blower door fan was in operation, the weatherization crew located air leakage locations with a smoke stick.

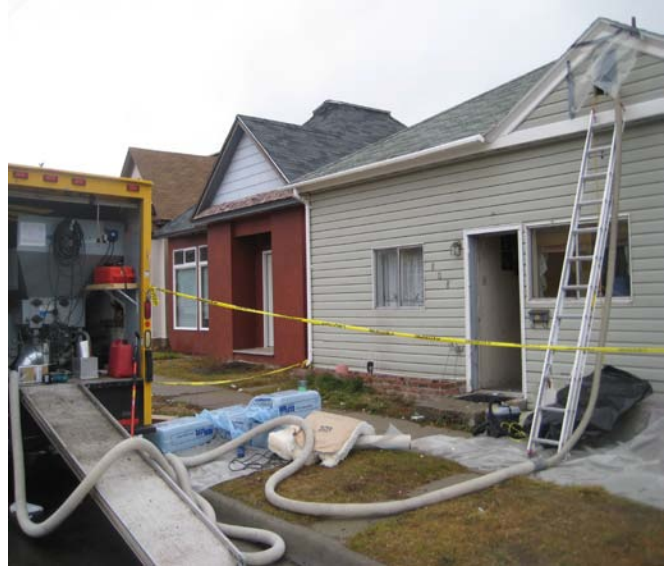
Figure A12

View of hose blowing insulation into attic.

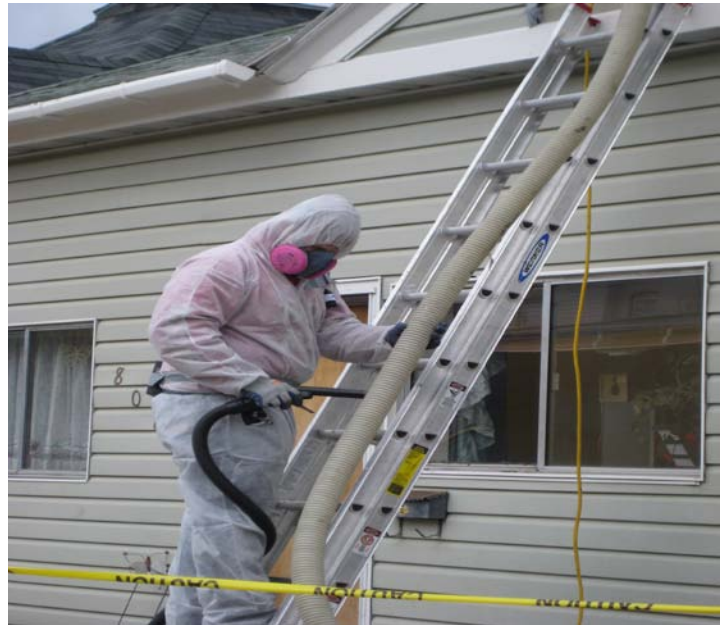
Figure A13

Crew member HEPA vacuuming hose after being removed from attic.

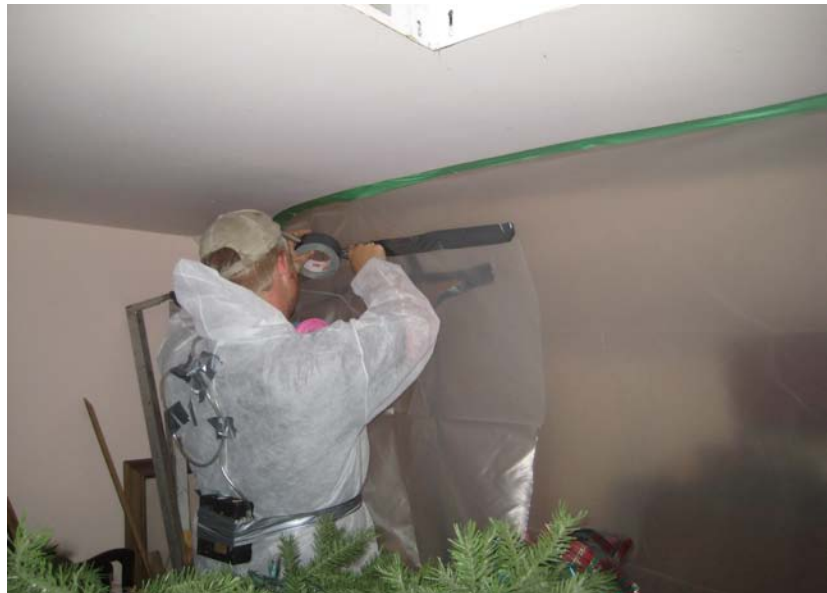
Figure A14:
Crew member building
containment prior to
wall blow-in.

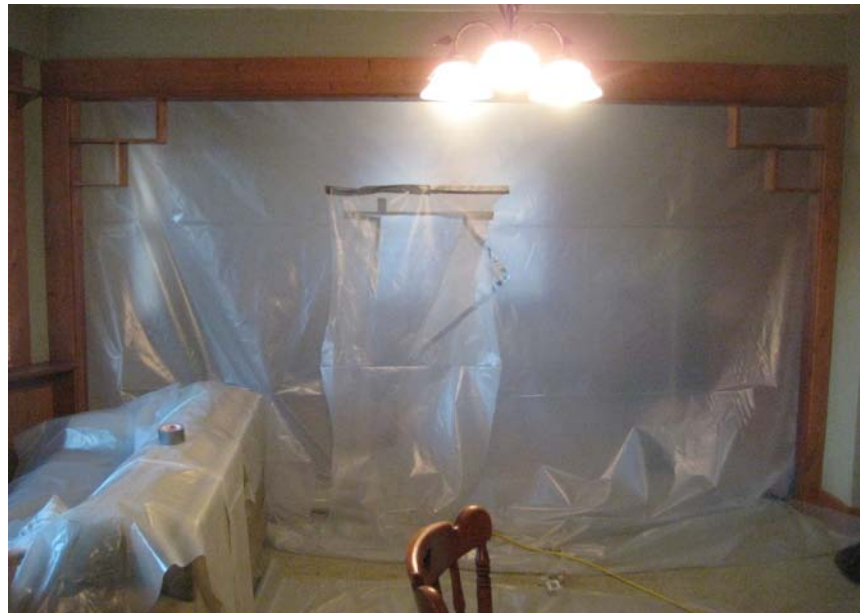
Figure A15
Example of
containment for wall
blow-in.

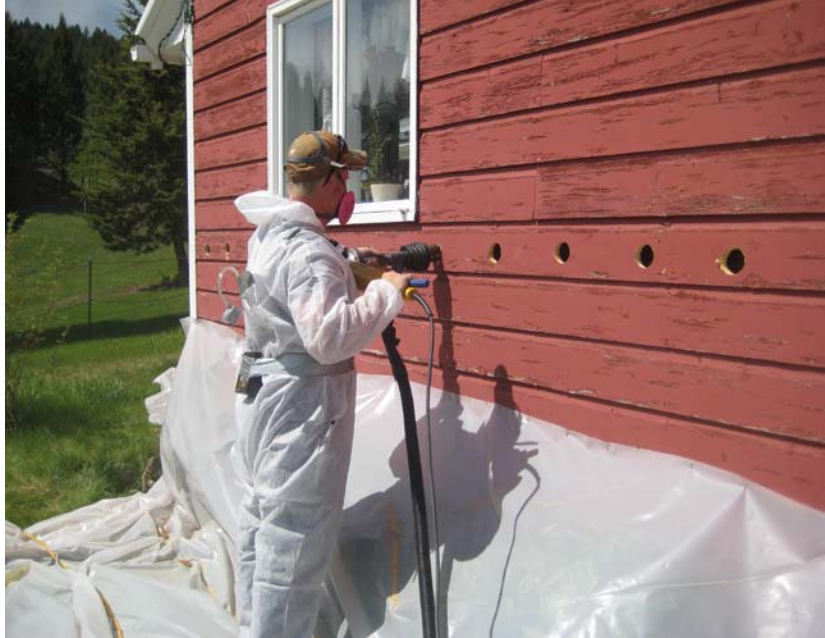
Figure A16

Crew member drilling exterior holes for wall blow-in.

Wall Insulation. Wall insulation typically was added by drilling holes in the exterior wall finish (Figure A16). If the house had exterior asbestos siding, then holes were drilled on the interior of the house for blowing insulation (Figure A17). Prior to insulating, penetrations and openings on the interior of exterior walls were repaired. If the wall was to be blown from the interior, 6-mil polyethylene was used to build containments in order to control fibers that might be disturbed during weatherization activities (Figures A14 and A15). Access holes were drilled for the insertion of a 1.5-inch tube used for blowing insulation.

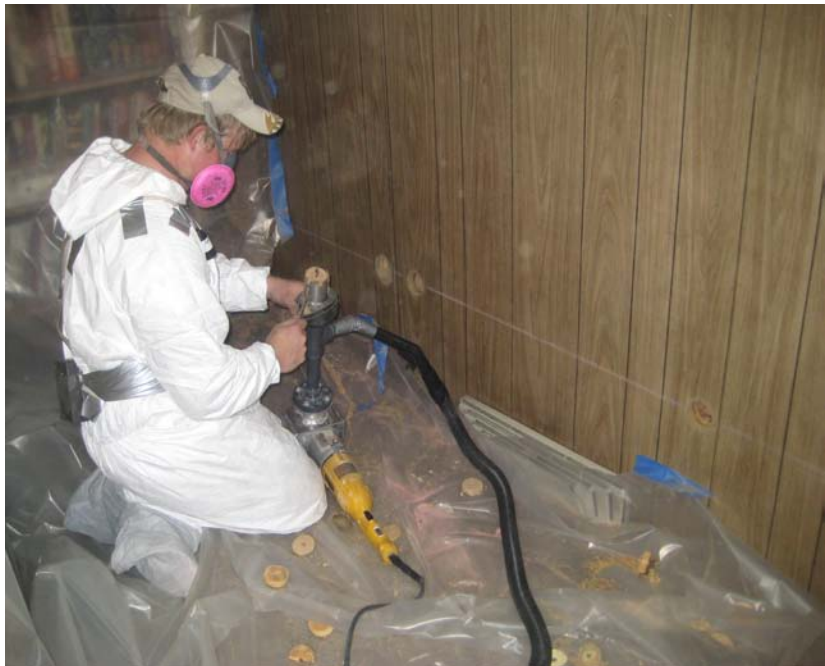
Figure A17

Crew member drilling interior holes for wall blow-in.

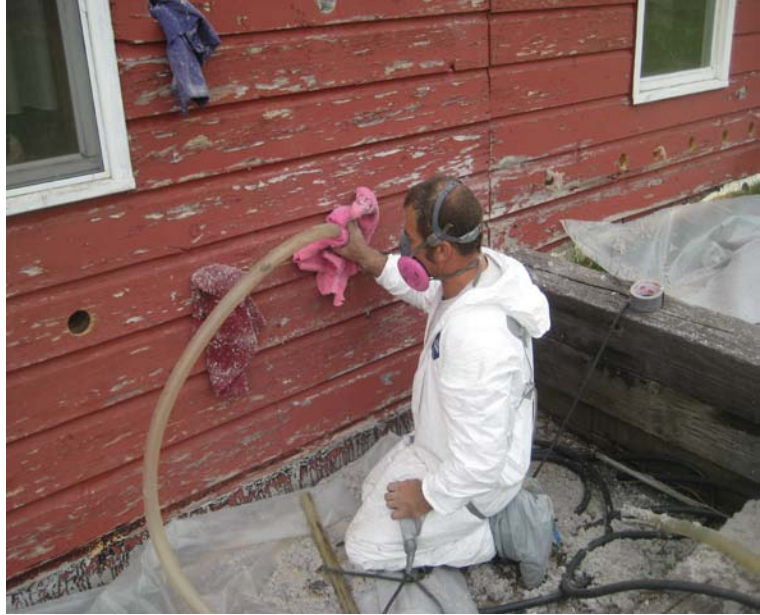
Figure A18

Crew member blowing insulation into exterior wall.

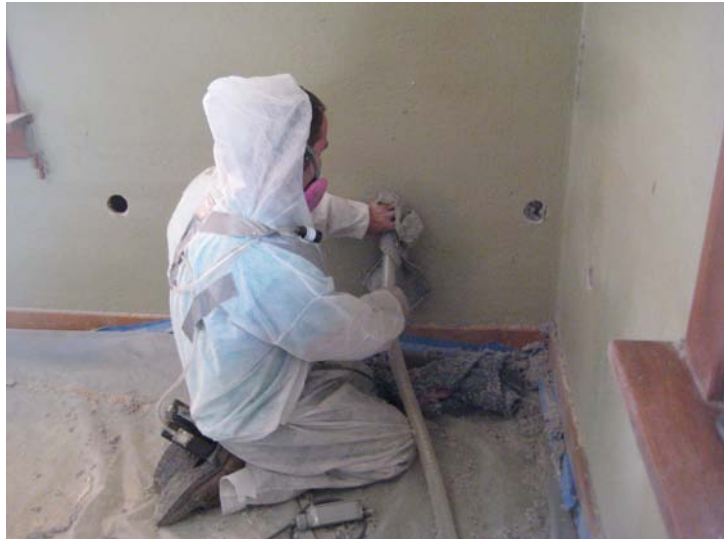
Figure A19

Crew member blowing insulation through interior wall.

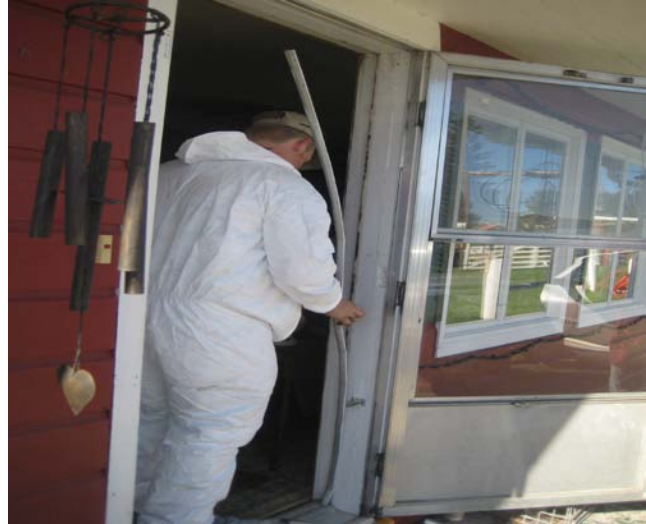
Figure A20

Crew member installing door weatherstripping.

Doors and Windows. Some exterior doors that were in poor condition were replaced. If appropriate, weatherstripping was replaced at existing doors. In addition, the thresholds were replaced on some exterior doors (Figure A20). Windows were weatherstripped, caulking (glazing) was applied, and broken glass was replaced as needed. No window replacements were performed during the project.
